QUICK REACTION REPORT ON THE
BAGHDAD POLICE COLLEGE
BAGHDAD, IRAQ

SIGIR PA-06-078.1

SEPTEMBER 27, 2006

Quick Reaction Report on the Baghdad Police College, Baghdad, Iraq

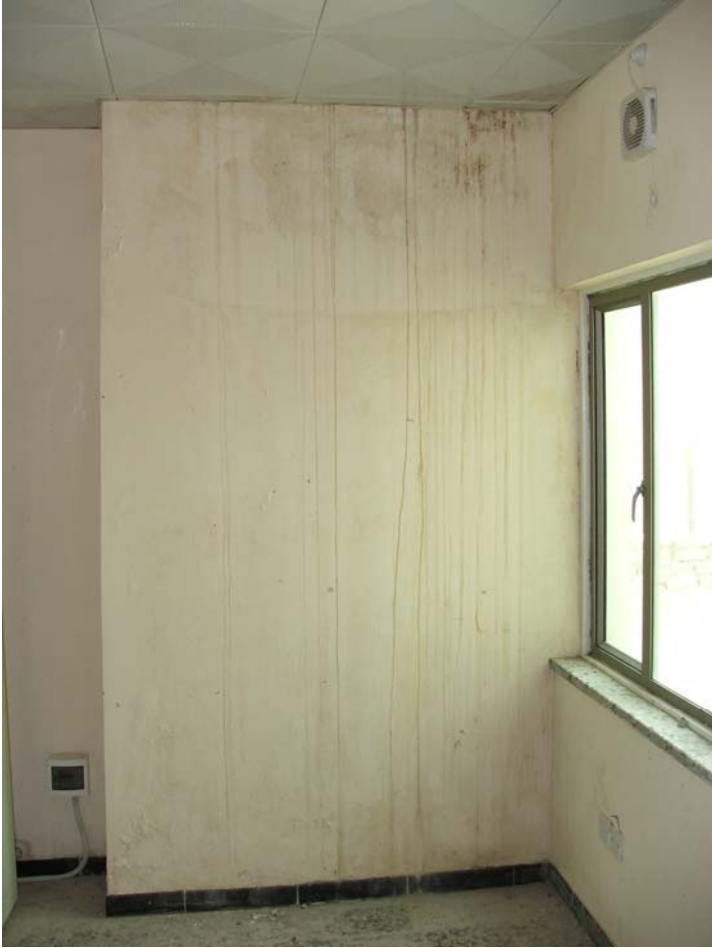
During our site visit, we immediately identified water damage and staining on the ceiling and walls of the ground floor (Site Photos 4 and 5). We toured the second floor bathroom and saw evidence of similar water damage and staining on the ceiling (Site Photo 6).

Site Photo 4. Water damage to wall

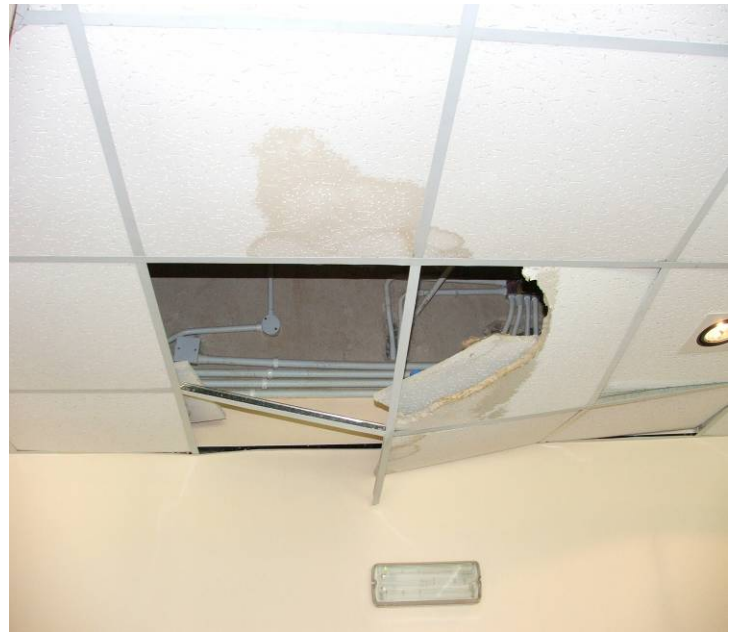
Site Photo 5. Water damage to ceiling

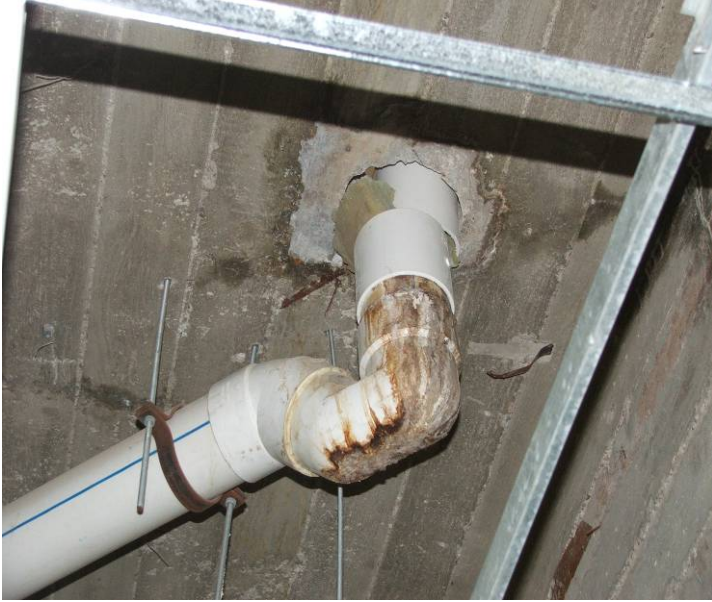
- Floor drains are not adequately sealed to the floor surface and/or properly affixed to adjacent fittings with the proper adhesive or sealant, which causes water to drain outside rather than inside the drain collectors (Site Photo 12 and 13)
- Drains were assembled without the specified molded plastic fittings, which resulted in water and waste materials flowing from the collection trees through the improperly fabricated joints directly into the concrete floors. The contractor used pipes with holes that were hand cut with secondary pipes inserted (Site Photo 14) rather than the appropriate type of pipe (Site Photo 15).

Site Photo 12. View of wastewater leaking from pipe

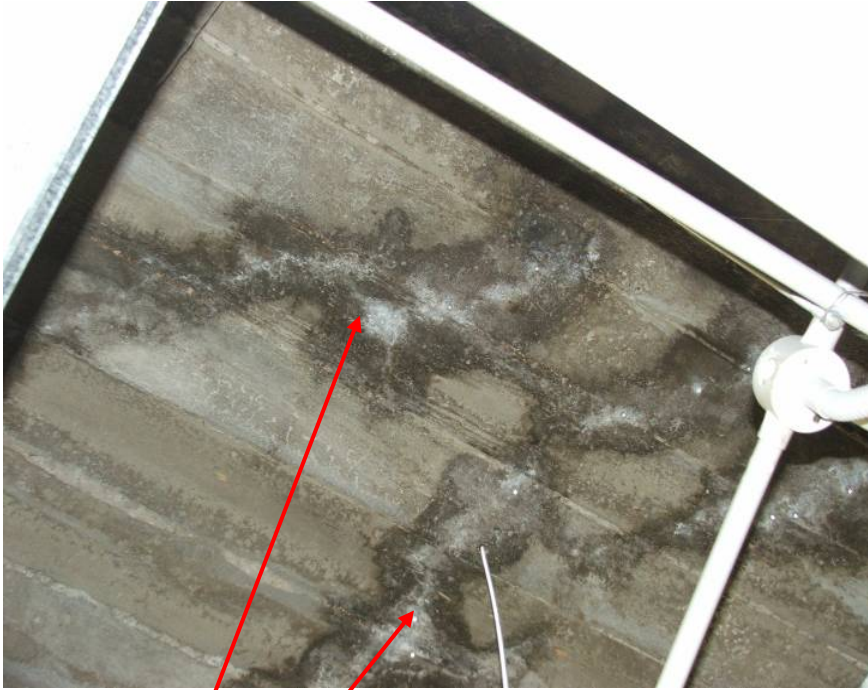
**Underside of 2nd floor
Concrete slab cracks with
soaked through with urine,
fecal matter and efflorescence.**

1. Perform an assessment of all wastewater plumbing installations in all newly constructed buildings, both single and multiple storied, sponsored under this contract. This assessment will be to determine if similar methods of inadequate plumbing techniques were utilized in other project locations as were discovered in the cadet barracks buildings.
2. Perform a critical technical study of the structural integrity and load carrying capacity, as well as the potential environmental and health hazards posed by the rust, mold, and presence of urine and fecal matter within the concrete floor slabs of the cadet buildings to the Baghdad Police College students and staff.
